TABLE OF CONTENTS

1.	Interface Control Ra180-12 Module	3
2.	Assembly Drawing Ra180-12 Module 1 of 2	4
3.	Assembly Drawing Ra180-12 Module 2 of 2	5
4.	Redundant Bus Solar Cell 1.885 x 3.735	6
5.	East-West View Integral Mounting	9
6.	North-South View Integral Mounting	10

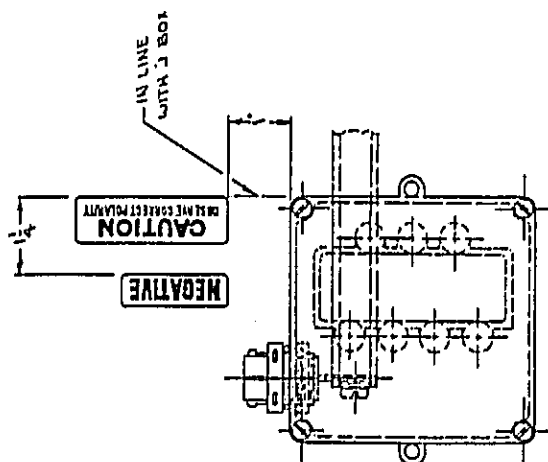
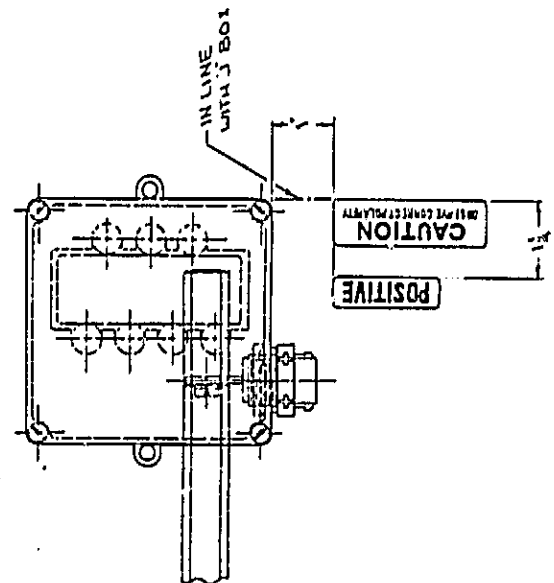
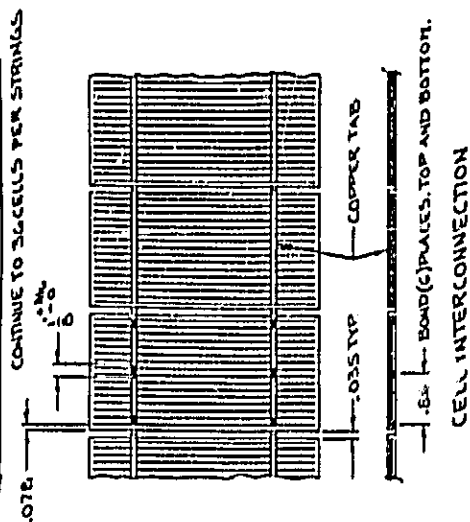
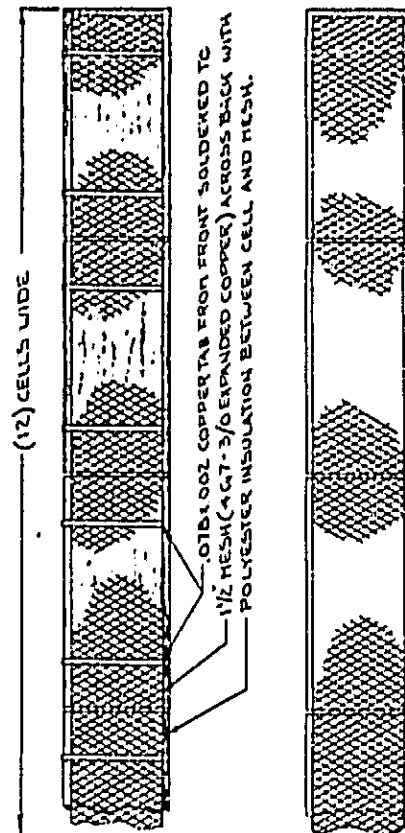
MODEL TYPE: **Solar Energy Corporation**
 ASSEMBLY DRAWING
 SCALE: 4 TO 1
 DATE: 10/26/75
 DRAWING NO.: **2005055**
 SHEET 1 OF 2

STRING INTERCONNECTION AND
CROSS TIE BACK VIEW
